## Cunningham Upgrade

By Derek Martin

June 2008

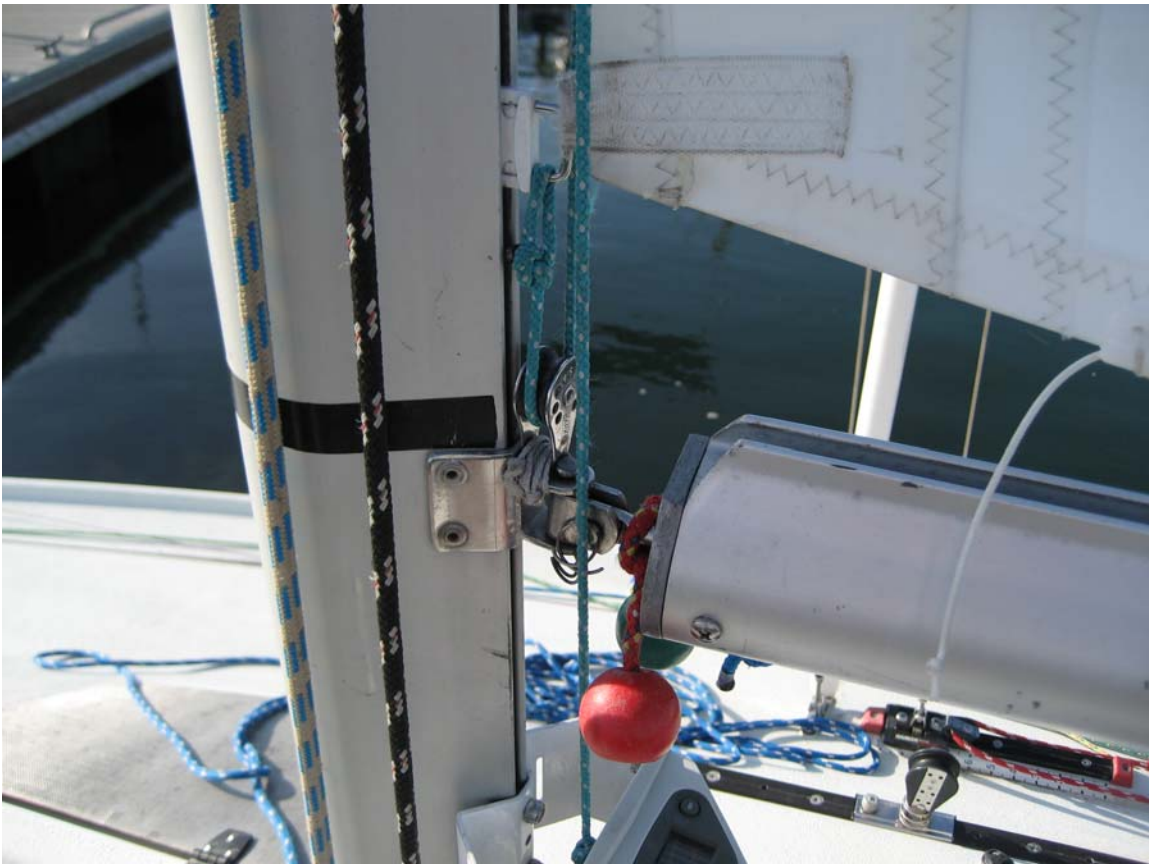
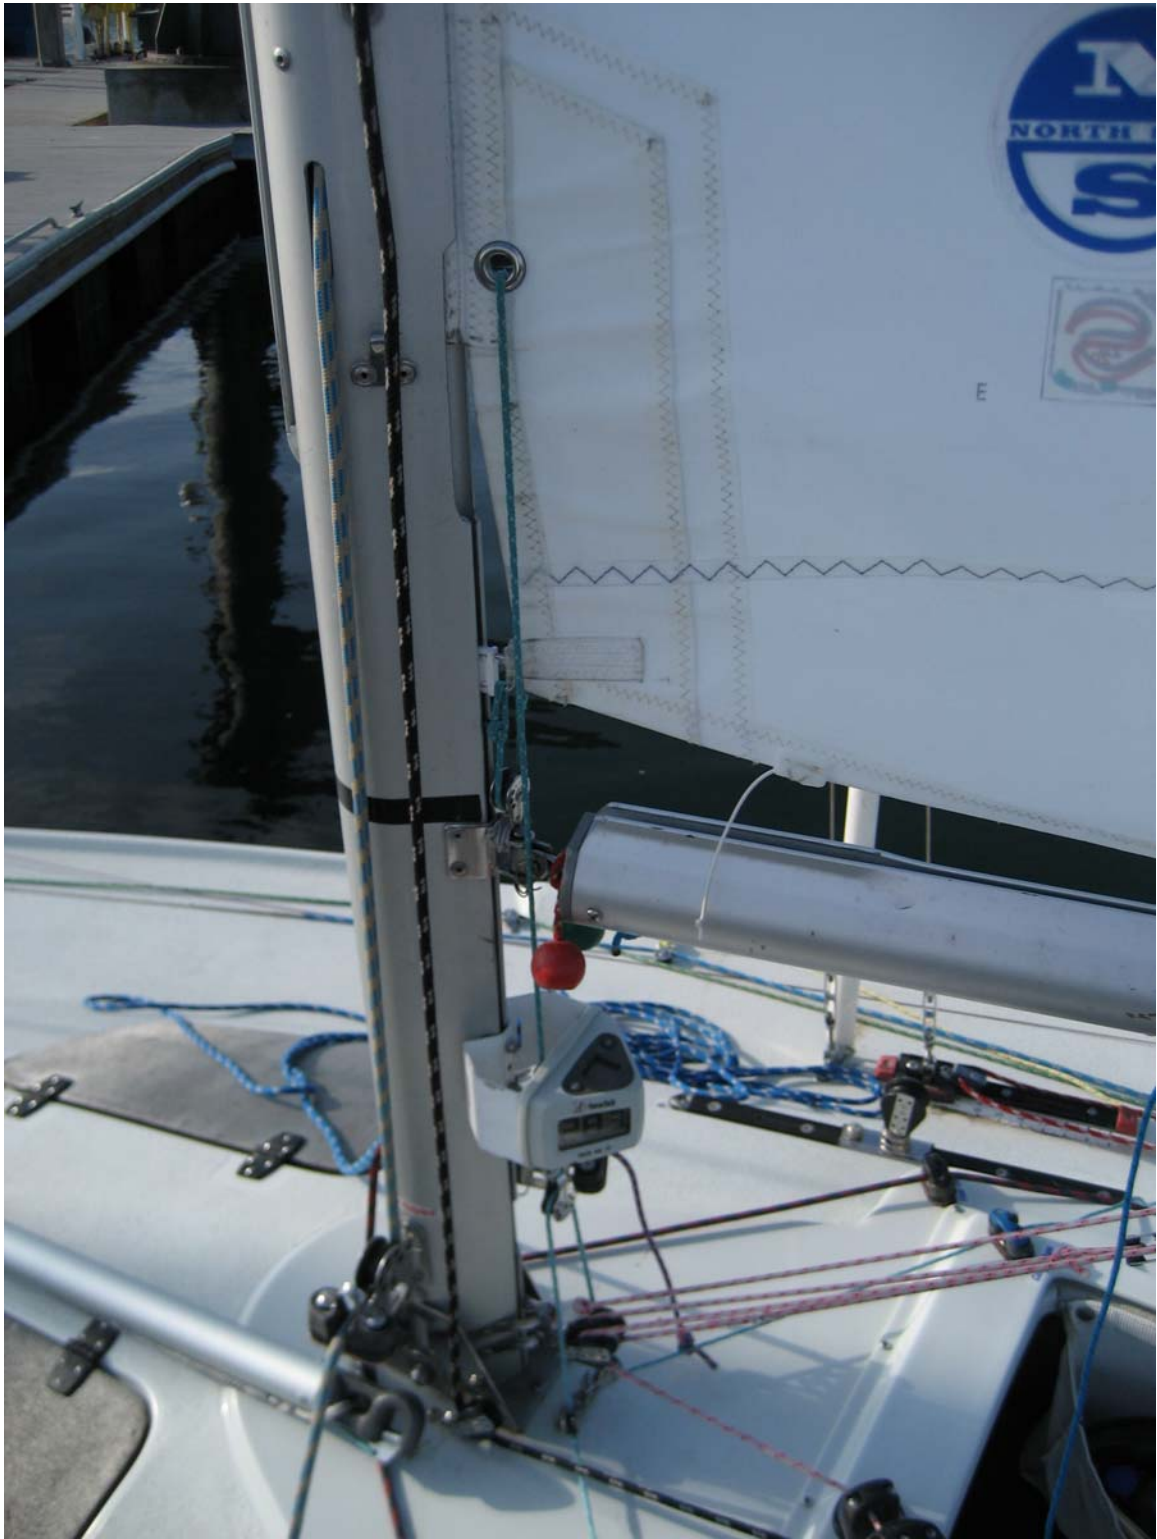
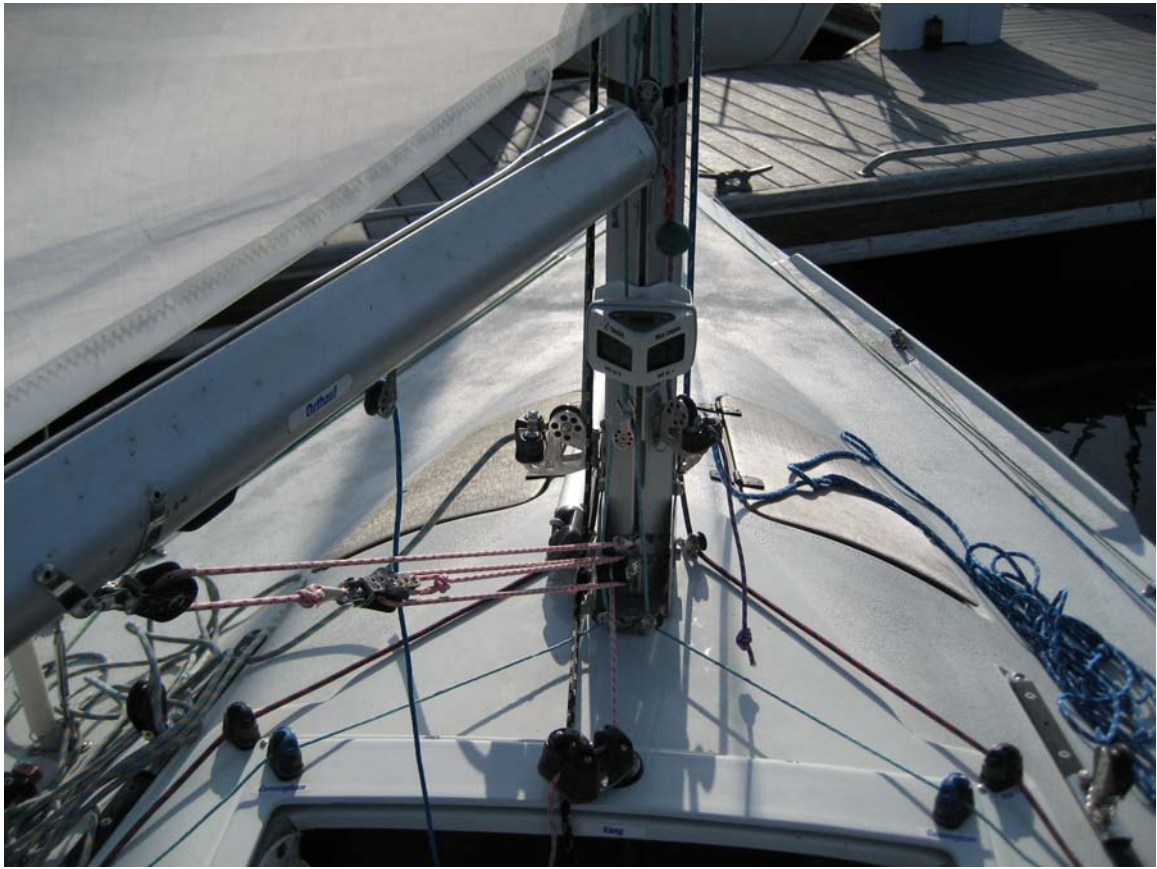
Much like the "stock" Cunningham system offered on new Santana 20s, this system uses two lines. The first line consists of a line running from a cleat on one side of the cabin top, through a small block at the base of the mast, up through a "floating" small block (more in a minute), back down to another small block at the base of the mast, and over to a cleat other side of the cabin top. The floating block has a small shackle fixed to it that is clipped into the bowline loop described above.

The second line starts at the bottom slug of the mainsail, goes down through a small block lashed to the top of the gooseneck, back up and through the Cunningham grommet in the mainsail, then back down along the port side of the gooseneck (through the middle of my compass bracket), where it terminates in a small bowline loop.

This system ensures downward tension on both the grommet and the sail slug. It operates very smoothly and moves both in unison - leaving no chance for a wrinkle in the sail to form.

The photos show this system on Gratitude" (hull #926).
